## APARTMENT INSPECTION REPORT

**Mountain Paradise, Bansko  
Apartment 2206 (A14)**

We visited the property in Mountain Paradise complex, Bansko, apartment 2206 (according to the apartment old numbering it was A14) on 9<sup>th</sup> of April 2007. We carried out all necessary inspection tools and completed the following report.

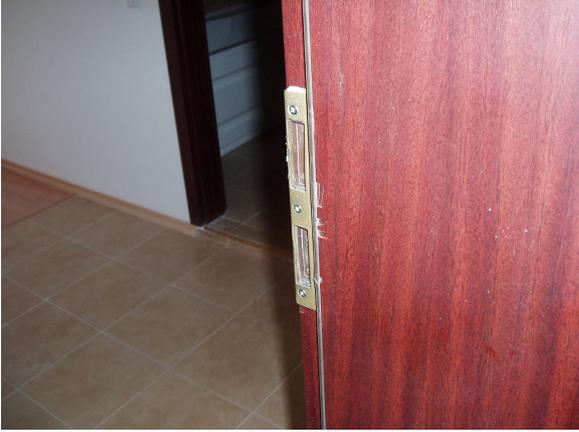
1) The frame of the entrance door has some scratches.

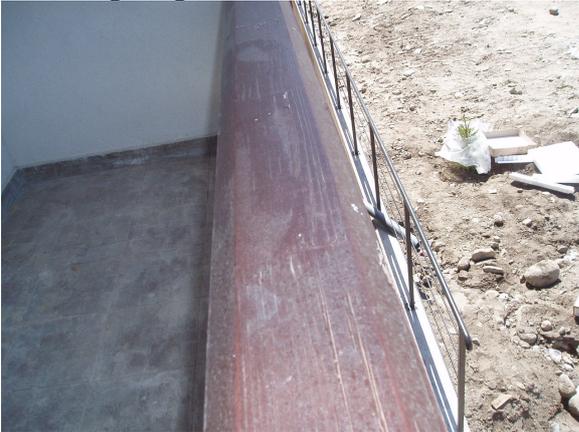
2) The parapet of the terrace needs to be polished.

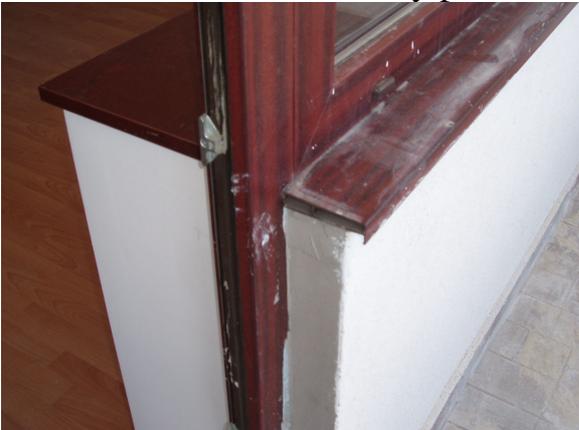
3) The horizontal border of the windows frame is not capped. Also the area around the frame is not fully painted.

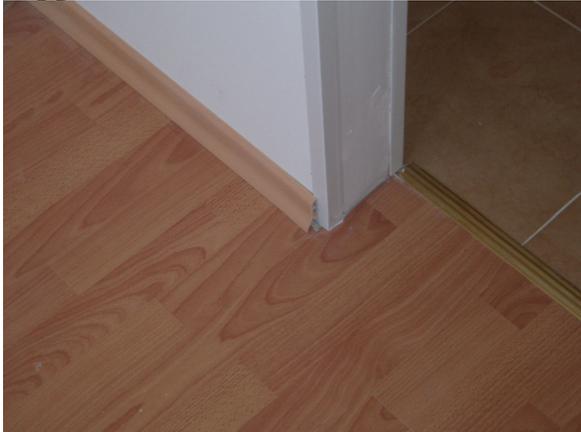
4) The border separating the laminate floor from the wall in the bedroom is not capped.

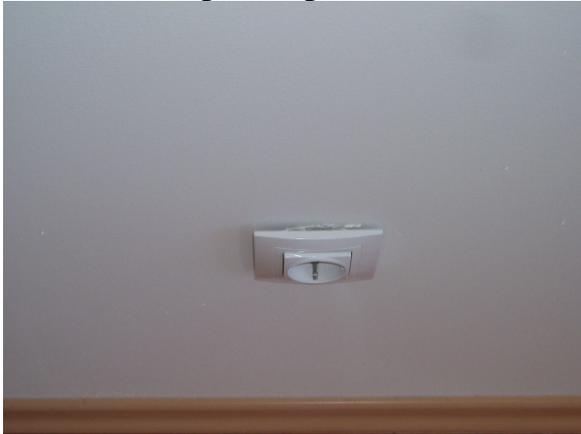
5) There is a power point in the bedroom, which is not well stuck.
