## APARTMENT INSPECTION REPORT

**Mountain Paradise, Bansko  
Apartment 2206 (A14)**

We visited the property in Mountain Paradise complex, Bansko, apartment 2206 (according to the apartment old numbering it was A14) on 9<sup>th</sup> of April 2007. We carried out all necessary inspection tools and completed the following report.

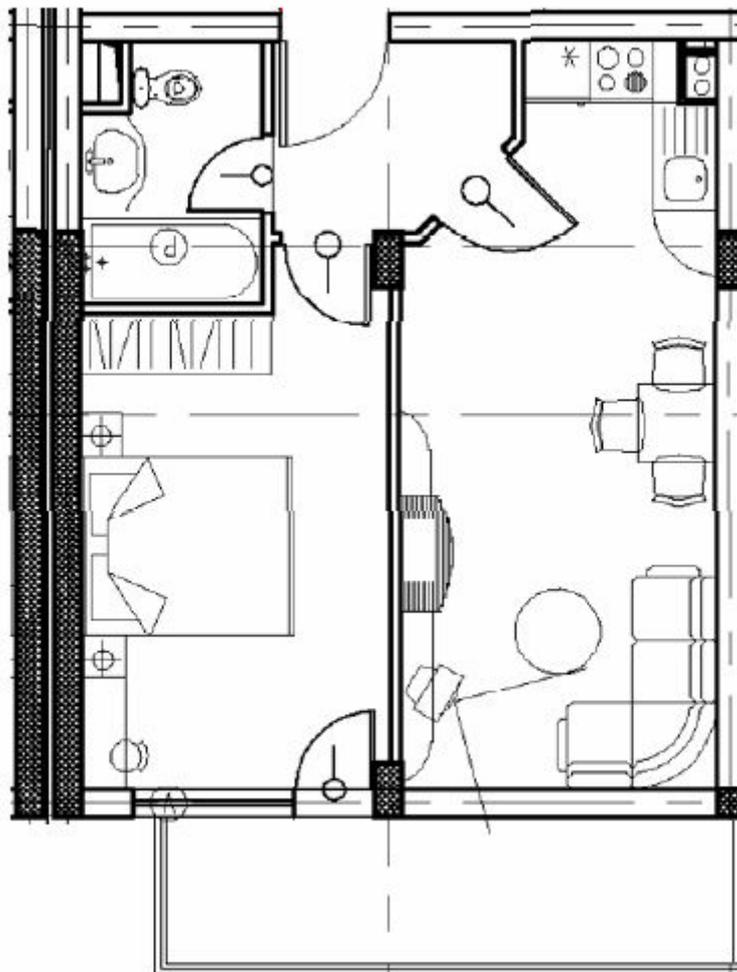
The entrance hall is with terracotta floor and the walls are painted in white. In the entrance hall there will be a wardrobe with a coat hangers.

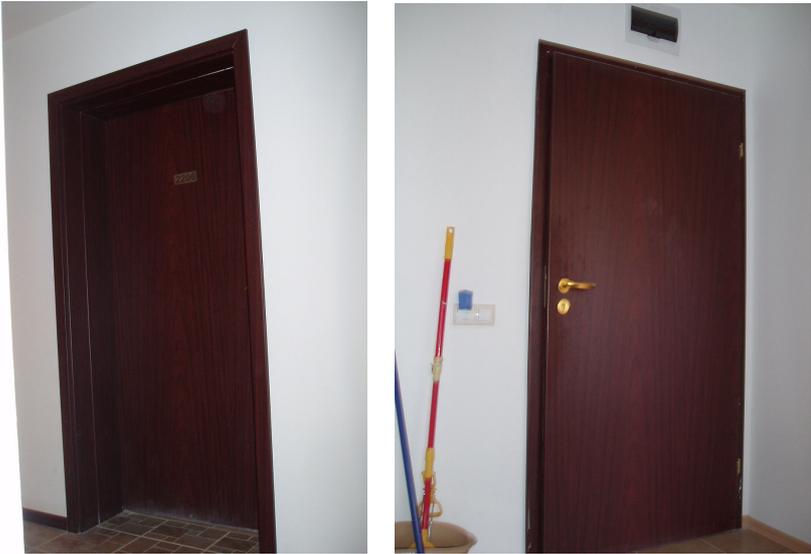
The switches and the lights in the entrance hall are placed and working. Over the entrance door is placed the electric panel of the apartment.

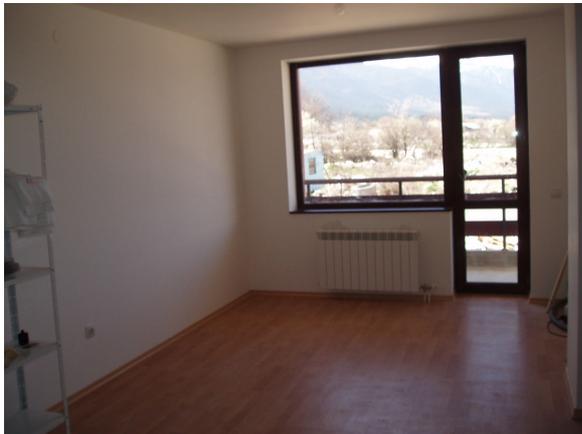
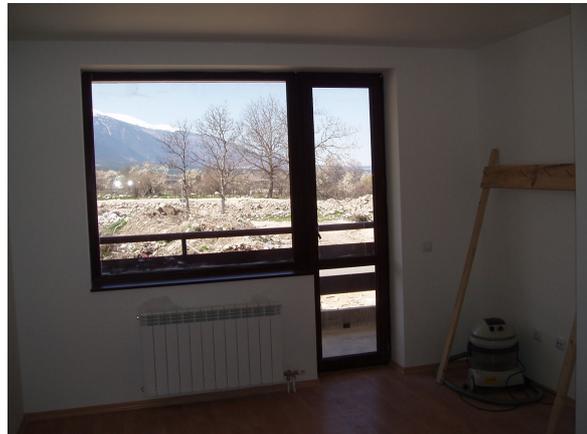
In the living room there is a kitchen area. In the kitchen area there will be a set of fitted kitchen cupboards and kitchen equipment, but it is still not placed.

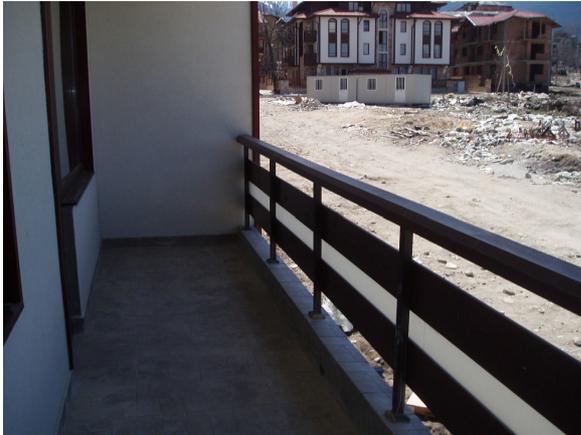
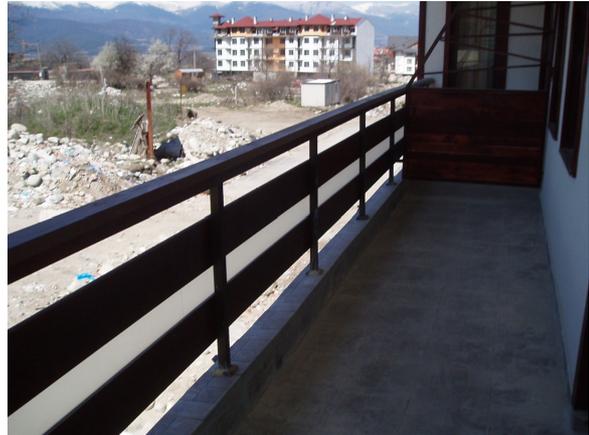
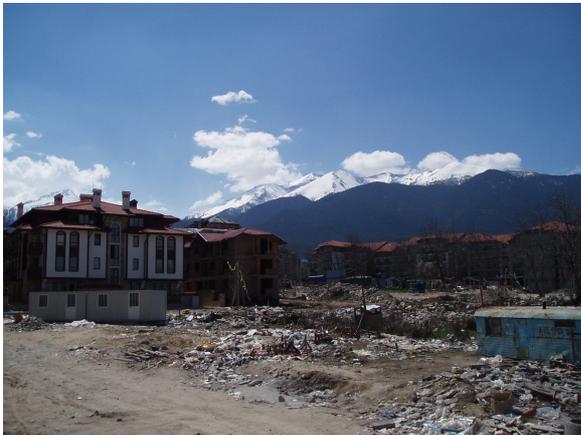
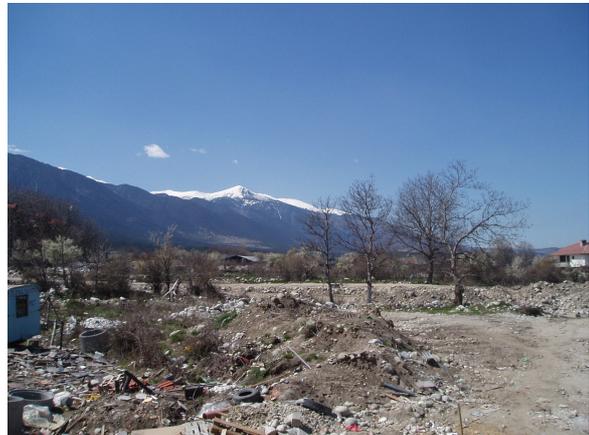
The façade of the building is finished. It is isolated from outside. All the construction is done properly.

The electric system in the building is done properly. All electric contacts are placed and attached. All switches and plugs are placed and working.
